FPSO 5.5" Reconnection Wire Rope Replacement

Client: Woodside Energy Ltd

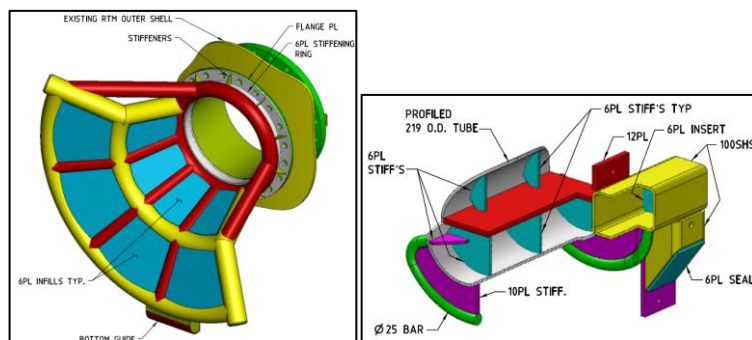
External Bellmouth

Inner Guide (cut away view)

- Catenary analysis of the wire assembly spanning between the RTM and the AHT to determine load and deflection ranges.
- Assessment of winch load increase due to friction around bends within the RTM.
- Design of a number of structural aids to guide the wire assembly around sharp edges.
